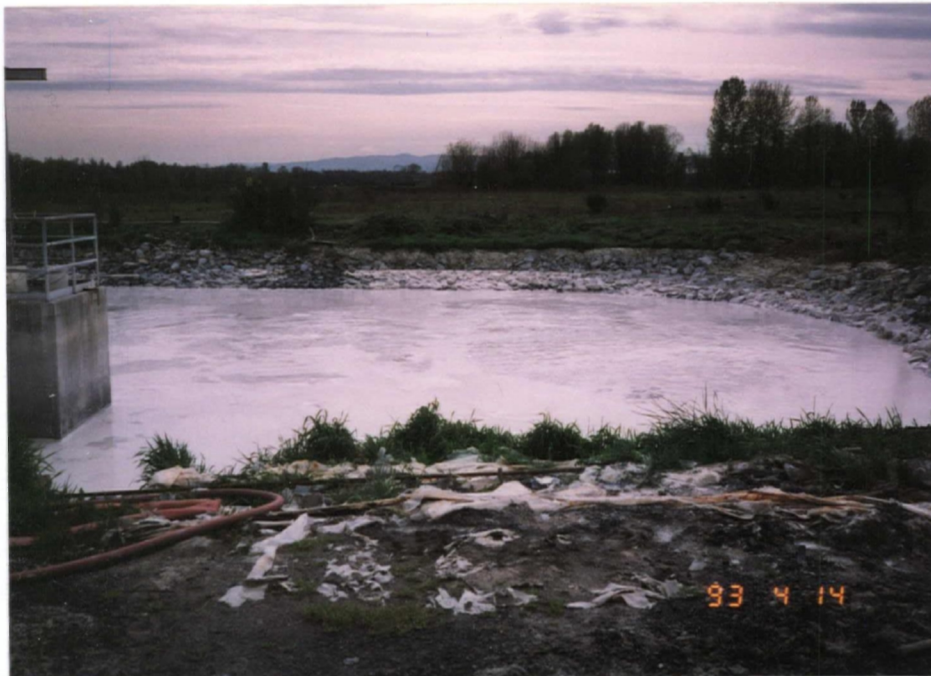
Photograph: 1	Date: 4/14/93	Taken By: Howe	Direction Facing: South
Description: Recirculation pond; former lagoon location in background

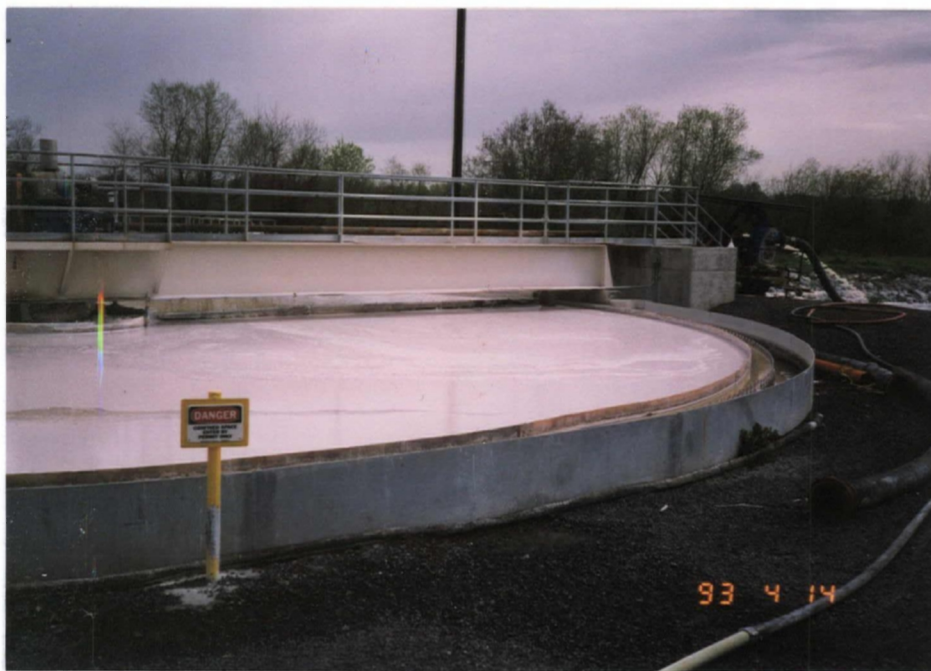
Photograph: 2	Date: 4/14/93	Taken By: Howe	Direction Facing: Southeast
Description: Primary clarifier

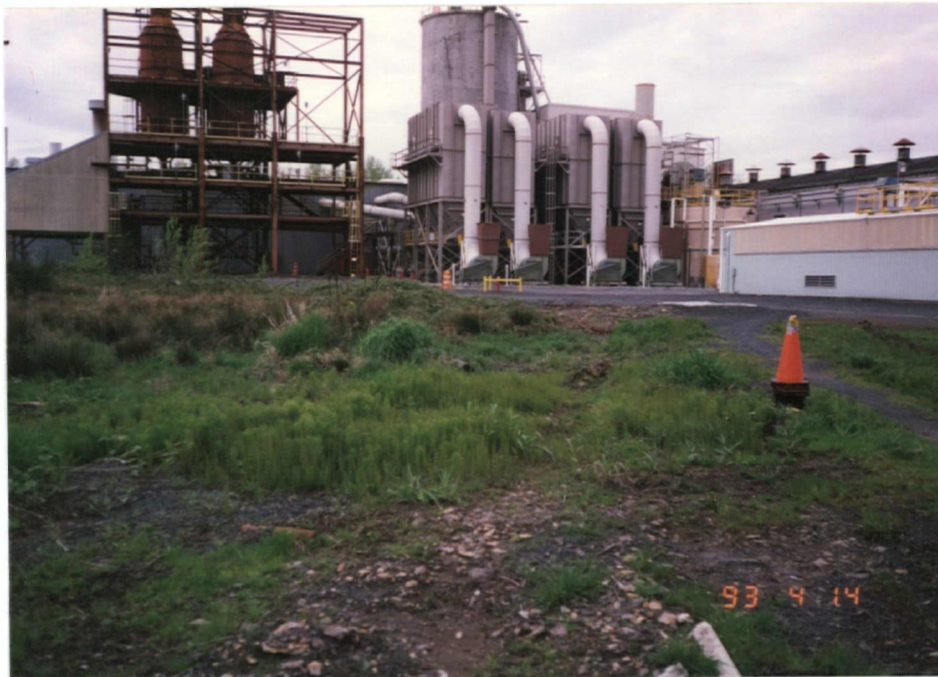
Photograph: 3	Date: 4/14/93	Taken By: Howe	Direction Facing: Northwest
Description: Location of former sludge holding pond (foreground)

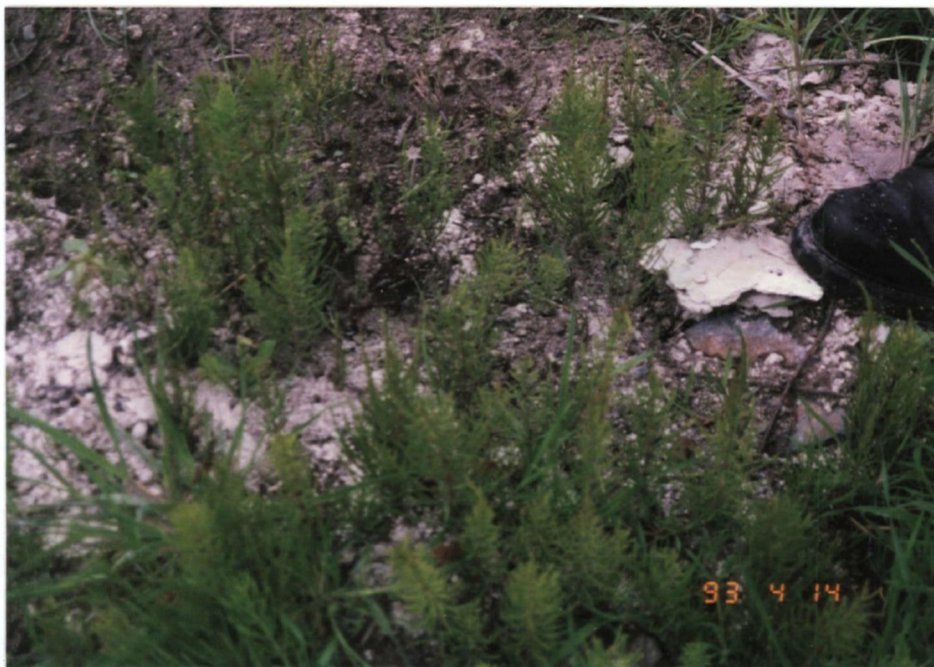
Photograph: 4	Date: 4/14/93	Taken By: Howe	Direction Facing: N/A
Description: Surface of former sludge holding pond

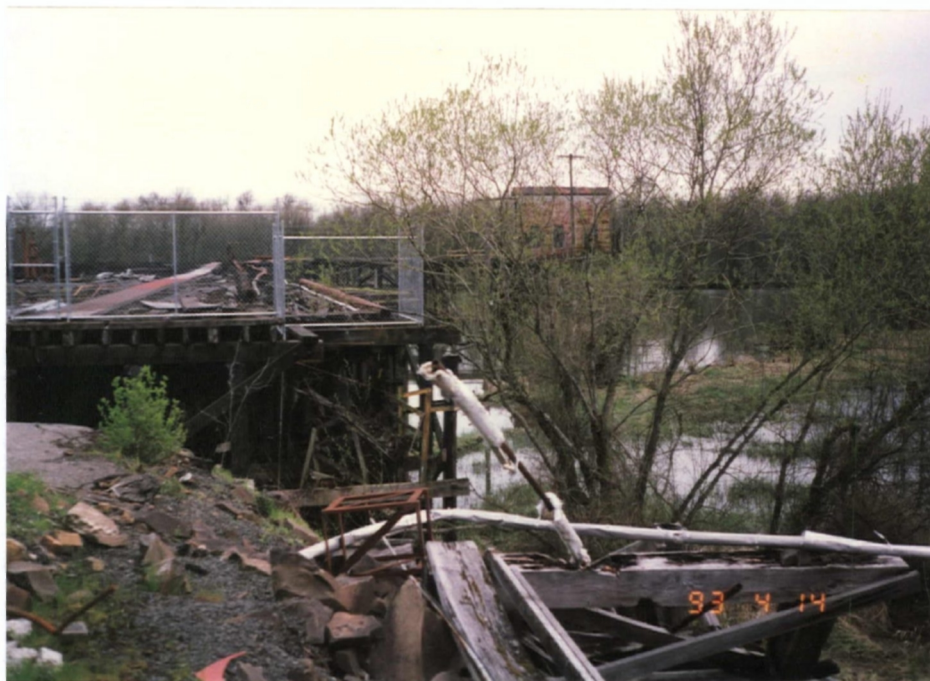
Photograph: 5	Date: 4/14/93	Taken By: Howe	Direction Facing: Southeast
Description: Former outfall location (at reddish building in background) and old pier

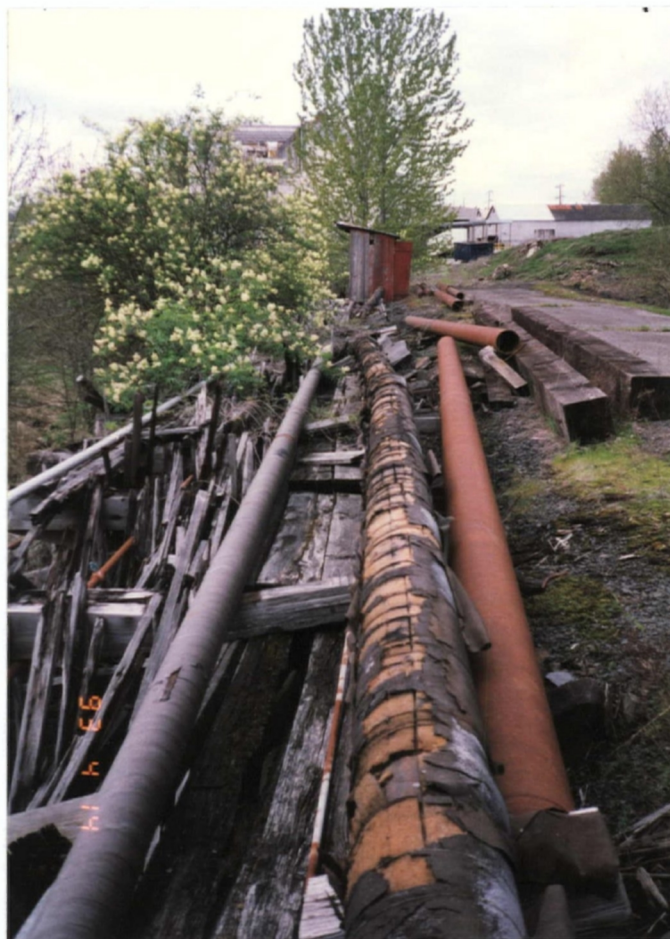
Photograph: 6
Date: 4/14/93
Taken By: Howe
Direction Facing: Northwest
Description: Old effluent pipe (center), and water intake pipes.

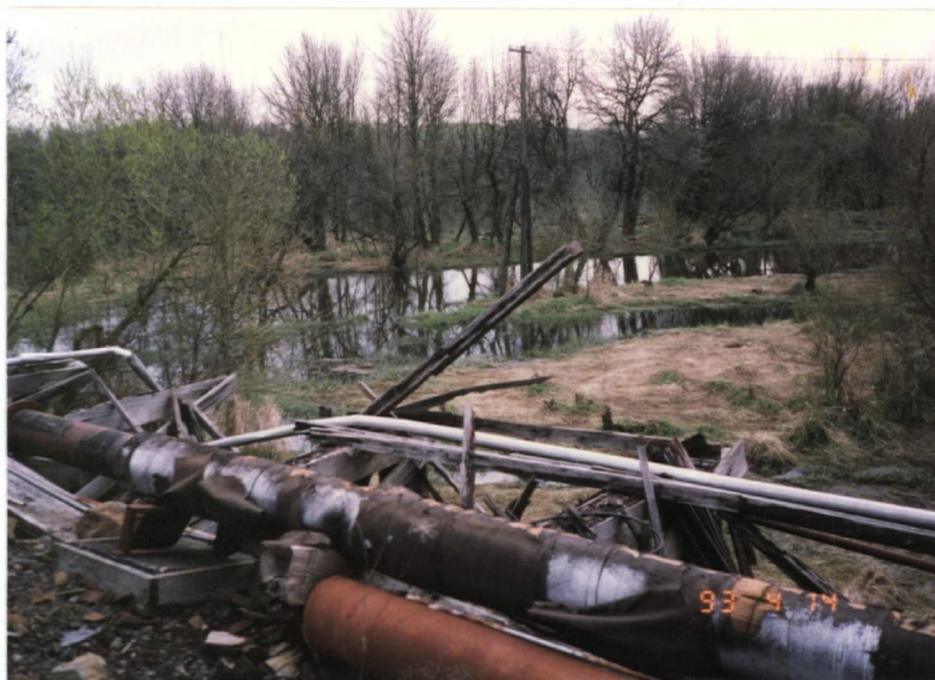
Photograph: 7	Date: 4/14/93	Taken By: Howe	Direction Facing: South
Description: Former effluent pipe and current wetlands

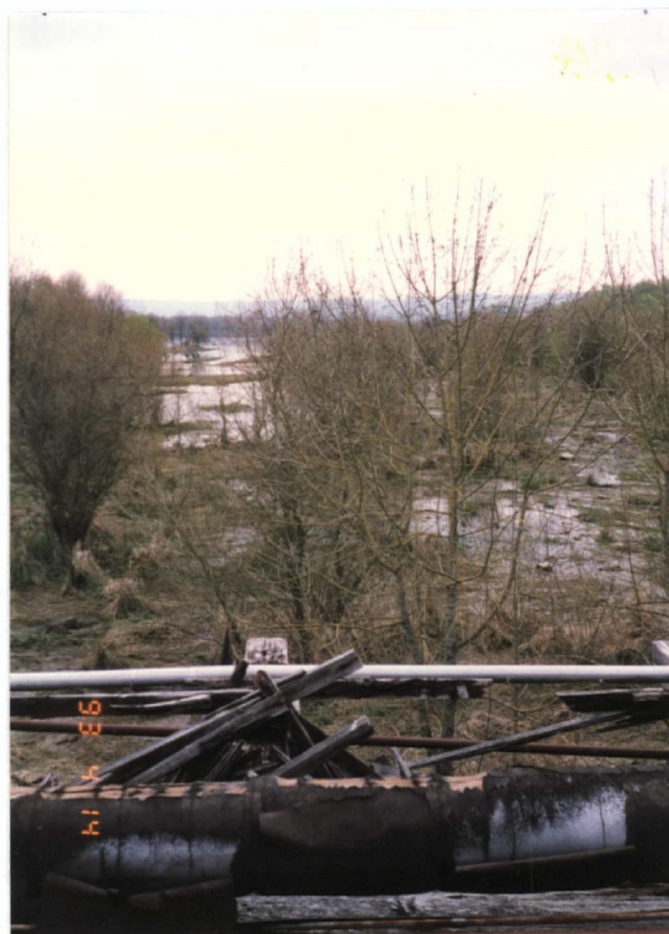
Photograph: 8
Date: 4/14/93
Taken By: Howe
Direction Facing: Southwest
Description: Former effluent pipe (closest to front) with Scappoose Bay wetlands in background.

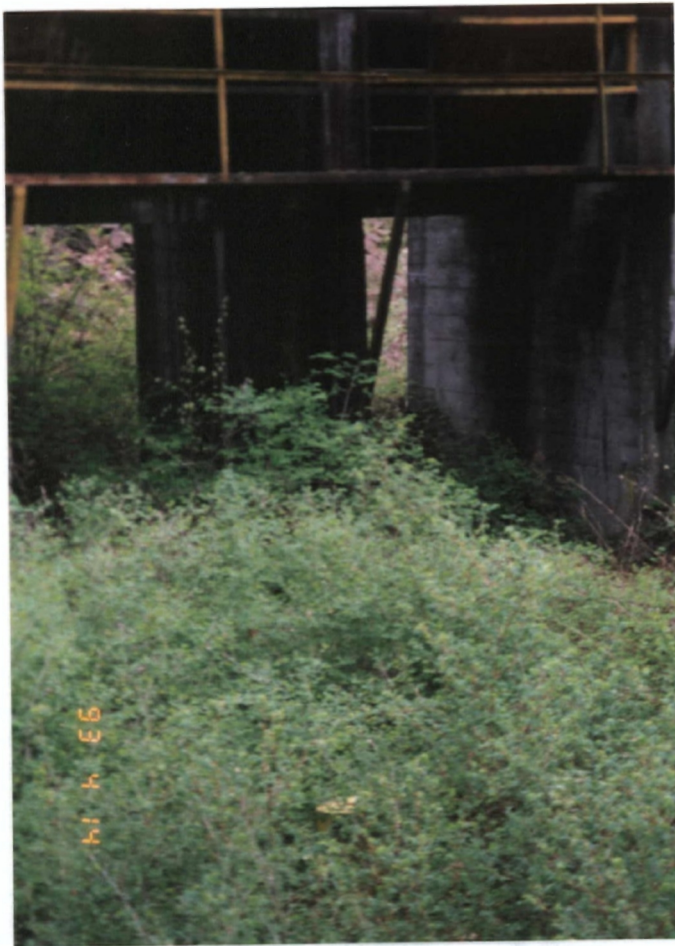
Photograph: 9

Description: Monitoring well MW1 in front of old asphalt/naptha tank structure.

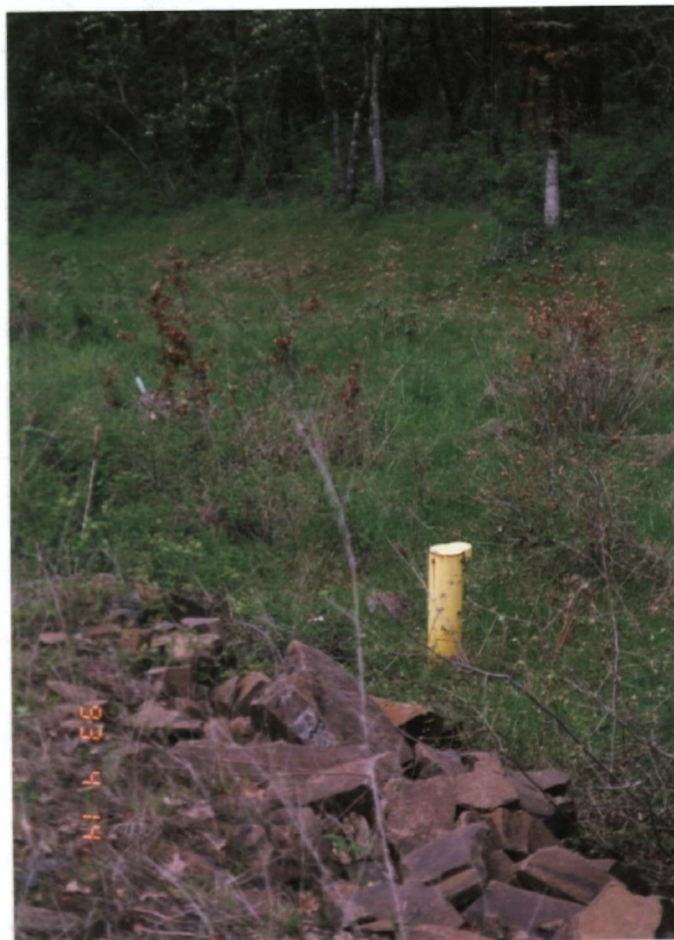
Photograph: 10

Description: Monitoring well MW1 in area of potential past spillage

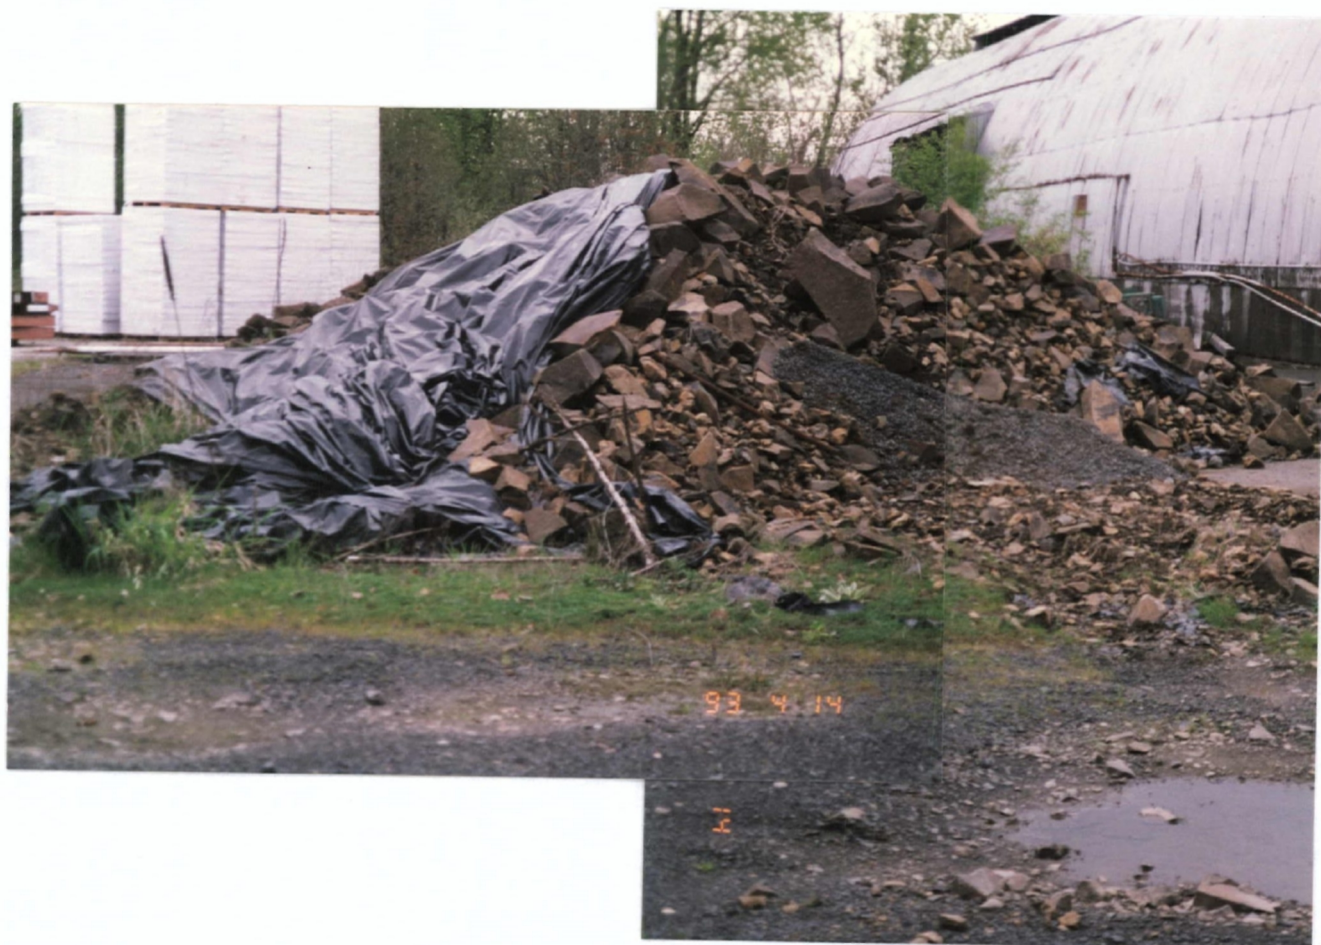
Photograph: 11	Date: 4/14/93	Taken By: Howe	Direction Facing: Southwest
Description: Waste pile of soils excavated near the quonset hut

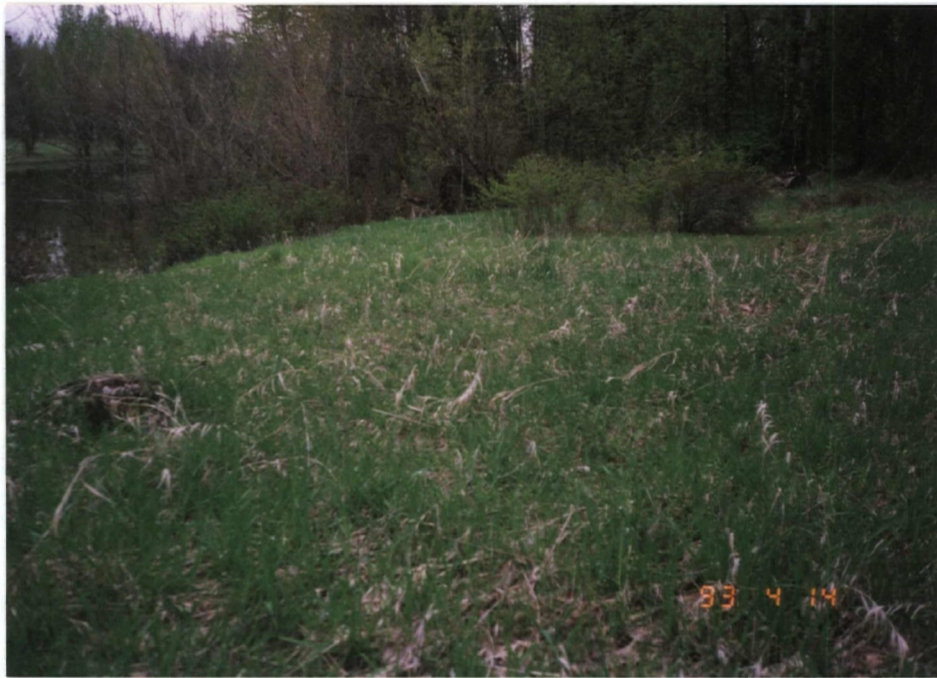
Photograph: 12	Date: 4/14/93	Taken By: Howe	Direction Facing: North
Description: Location of former burn area

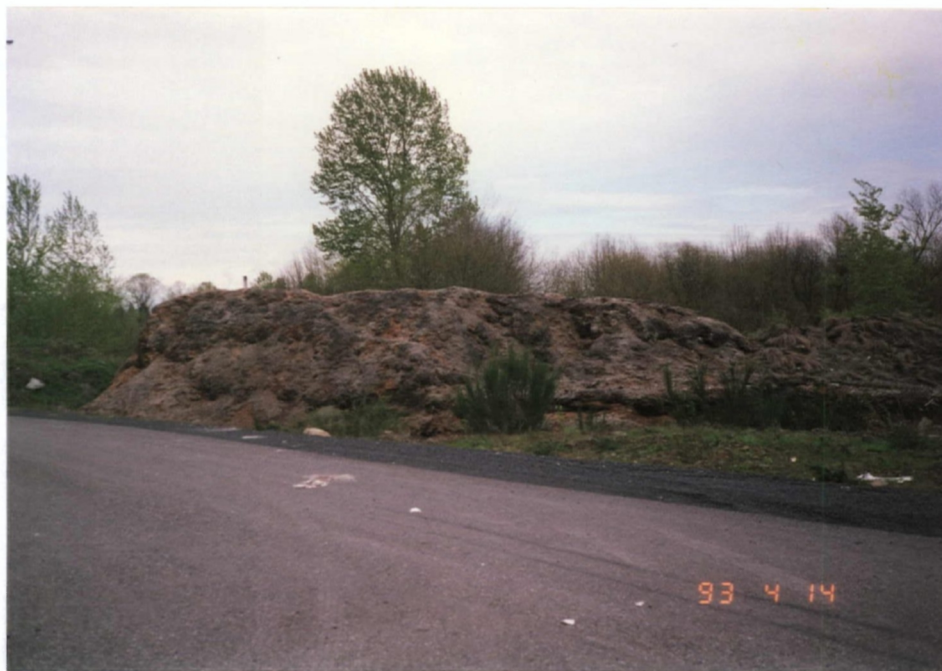
Photograph: 13	Date: 4/14/93	Taken By: Howe	Direction Facing: Unknown
Description: Old sawdust pile
